# ANNUAL REPORT FOR 2008

**UT to Adams Creek Mitigation Site  
Cabarrus County  
TIP No. R-2533B (Site 24)**

Prepared By:  
Natural Environment Unit & Roadside Environmental Unit  
North Carolina Department of Transportation  
September 2008

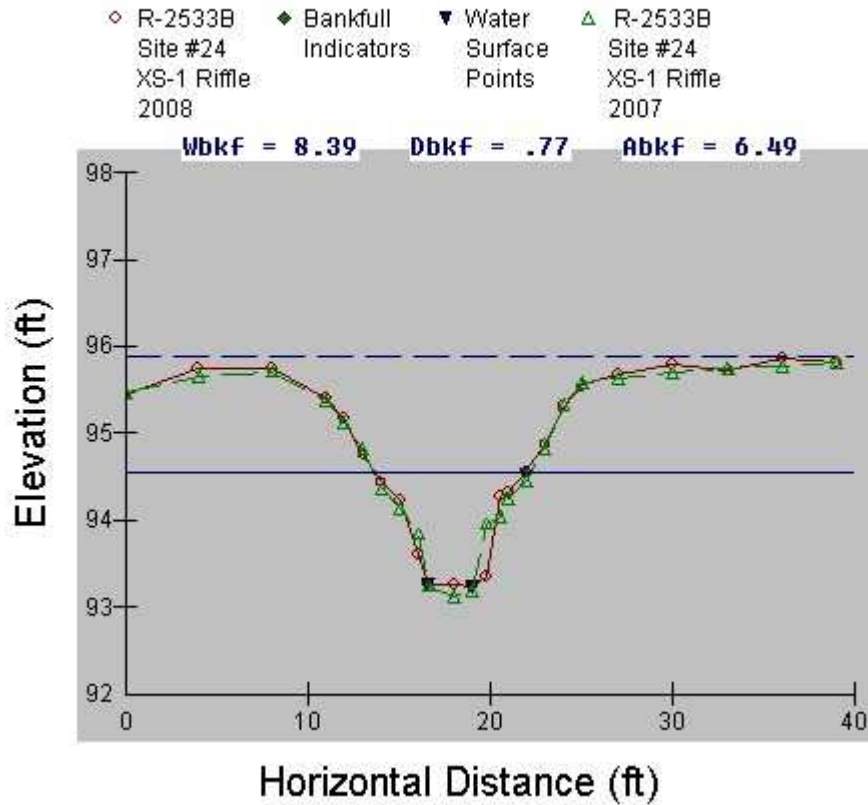
## R-2533B Site #24 XS-1 Riffle

Based on comparisons of Year 2007 and Year 2008 monitoring data, all of the cross sections appear stable with little or no active bank erosion. A bankfull event has occurred since the last monitoring evaluation. Graphs of the cross sections are presented in Appendix A. Future survey data will vary depending on actual location of rod placement and alignment; however, this information should remain similar in appearance. Pebble counts were not required per the permit conditions and therefore were not completed.

**Site #24: Cross-Section #1 (Riffle) Abbreviated Morphological Summary**

2007	2008	2009	2010	2011
Bankfull Cross Sectional Area (ft <sup>2</sup> )	5.5	6.5			
Maximum Bankfull Depth (ft)	1.3	1.3			
Width of the Floodprone Area (ft)	36.6	39			
Bankfull Mean Depth (ft)	0.7	0.8			
Width/Depth Ratio	12.1	10.9			
Entrenchment Ratio	4.5	4.7			
Bankfull Width (ft)	8.2	8.4

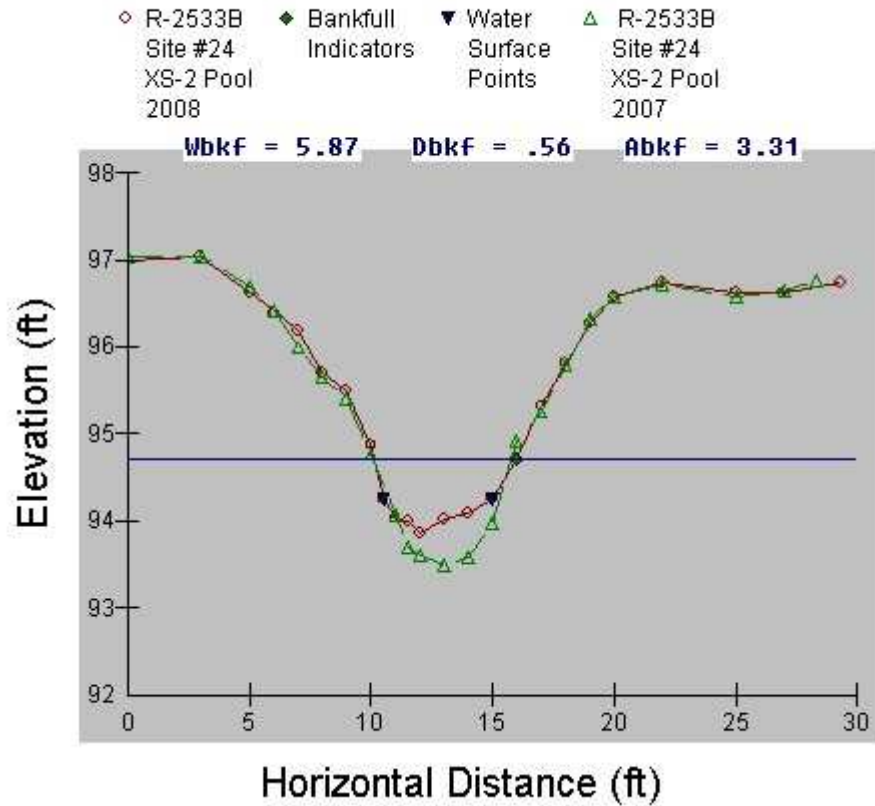
## R-2533B Site #24 XS-2 Pool

Site #24: Cross-Section #2 (Pool) Abbreviated Morphological Summary\*

2007	2008	2009	2010	2011
Bankfull Cross Sectional Area (ft <sup>2</sup> )	6.0	3.2			
Maximum Bankfull Depth (ft)	1.4	0.8			
Bankfull Mean Depth (ft)	1.0	0.6			
Bankfull Width (ft)	6.2	5.8
